## Irritation of the Suprascapular Nerve during Screw Placement in the Glenoid Component Implantation in Reverse Total Shoulder Arthroplasty: A Case Report

Department of Orthopedic Surgery and Traumatology, Cantonal Hospital Frauenfeld, Switzerland

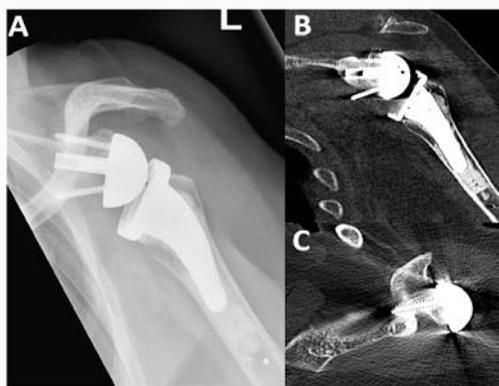
**Figure 1:** Glenoidal screw positioning. Conventional a.p. view of the shoulder after implanted reverse arthroplasty and conversion from an anatomic shoulder arthroplasty (A). The cranial screw runs towards the suprascapular notch. Images B and C provide axial and coronar view using CT scan, which show the penetration of the cranial baseplate screw into the suprascapular notch.

the suprascapular nerve. The CT scan revealed, however, prominent placement of the superior glenoid baseplate screw with penetration of the suprascapular fossa (Figure 1). Since the electromyography was negative, we decided against revision surgery.
