# Usefulness of Bilateral Plate Fixation for Distal Femoral Periprosthetic Fracture after Total Knee Arthroplasty

Department of Orthopedic Surgery, Konyang University Hospital, Korea

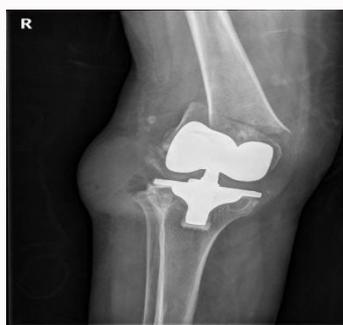
Figure 1A: Radiograph showed a complete displaced fracture, which was not seen at visiting an outpatient clinic.

A 76 years old woman brought emergency center by painful swelling in right knee caused by falling down from wheelchair. Right distal femur showed a periprosthetic fracture of the TKR operated 15 years ago (Figure 1A). Two days ago, she visited an outpatient department because of serous discharge from anterolateral aspect and varus instability of right knee. Radiographs, checked outpatient clinic, showed a huge mass like soft tissue lesion on anterolateral aspect of knee (Figure 1B). Joint fluid analysis showed that white blood cell count was 1728 and CRP 0.5 mg/dl. Culture result showed no growth for 48hr hours. We operated with lateral locking plate (Synthes, Switzerland) and changing a bearing insert with debridement of the huge mass and sinus track (Figure 2A). At post-operative 7 days, Candida was detected from the culture obtained at operation, equivalent to catheter tip culture. So after then, we use anti-fungal antibiotics. In 9<sup>th</sup> post-operative day, author felt the abnormal motion at fracture site at changing the dressing gauzes. We found fixation failure and reduction loss on the radiography (Figure 2B, 2C). Author removed the failed lateral plate, and reduced fracture and placed the new lateral plate again. Because of poor bone

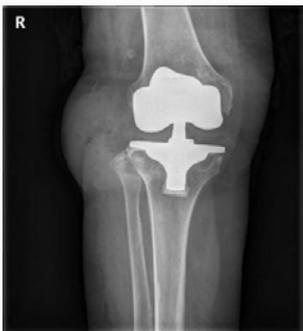
**Figure 1B:** Radiograph taken at outpatient clinic showed a huge soft tissue mass shadow on antero-lateral aspect of knee.

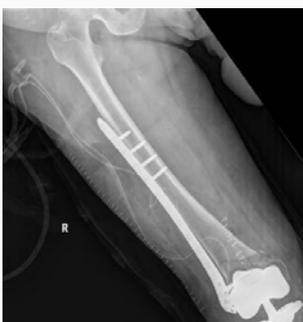
**Figure 2A:** Postoperative radiography showed a reduction of displaced fracture and fixation with LCP on the lateral side of femur.

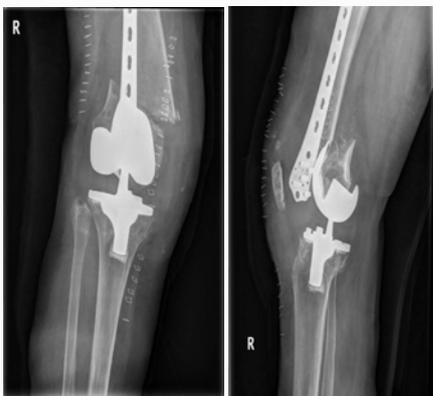
**Figure 2B-C:** At postoperative 9<sup>th</sup> day, radiograph showed the reduction loss of fracture and fixation failure.

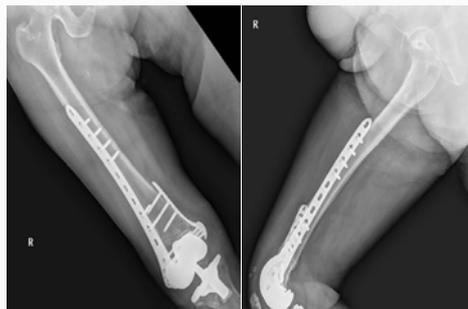
**Figure 3:** Radiographs at postoperative 6 months, showed a complete fracture healing with dual plating.

quality (total hip = -4.2 g/cm<sup>2</sup>) and chronic fungal infection, we could not acquire rigid fixation after lateral locking plating. In addition, author cannot use enough length of screws for penetrating the far cortex, because femur prosthesis was a posterior cruciate ligament scarifying type with a closed box. So we placed a LCP on the medial side additionally. After 6 months later, fracture was healed and infection was controlled (Figure 3).

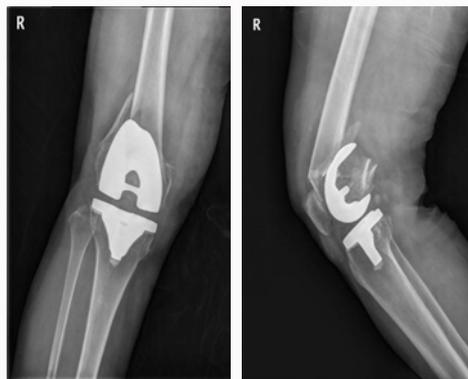
**Figure 4:** Preoperative radiographs showed that fracture line extends more distal than proximal border of an implant.

A 71-year-old woman brought emergency center by painful swelling on right knee after slipping down from a scooter. Periprosthetic fracture was shown in right distal femur. Fracture was severely comminuted on medial and lateral side and fracture line extended to distal to proximal femoral border of prosthesis (Figure 4).

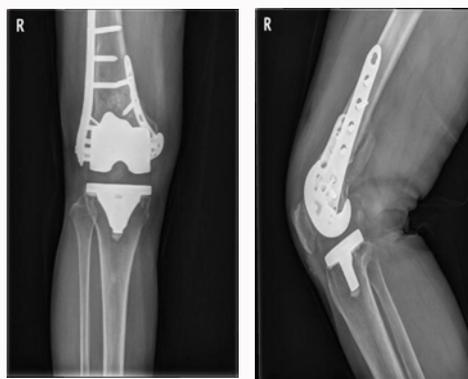
**Figure 5:** In the postoperative 6 months, radiographs show complete fracture healing after dual plating on both sides.

midline skin incision along the previous incision scar for a total knee replacement, and made a medial parapatellar approach. We retracted patella and confirmed fracture reduction and femoral component rotation and alignment. We checked the screws which not penetrate intercondylar box with native eye. After conforming secure fixation of fracture, we checked the stability of knee. The polyethylene insert was nearly wasted. So, we exchanged it with new one. Wounds were closed layer by layer. Post-operative 6 months, radiography shows complete healing of the fracture (Figure 5).
